International Research Project on the Effects of Chemical  
Ageing of Polymers on Performance Properties

**MECHANICAL AND PHYSICAL  
PROPERTIES OF BOTH UNAGED  
AND AGED COFLON AND TEFZEL**

**Document Number:** CAPP/M.12 Rev.A

**Document Date:** 11th June 1996  
Revised 18th March 1997

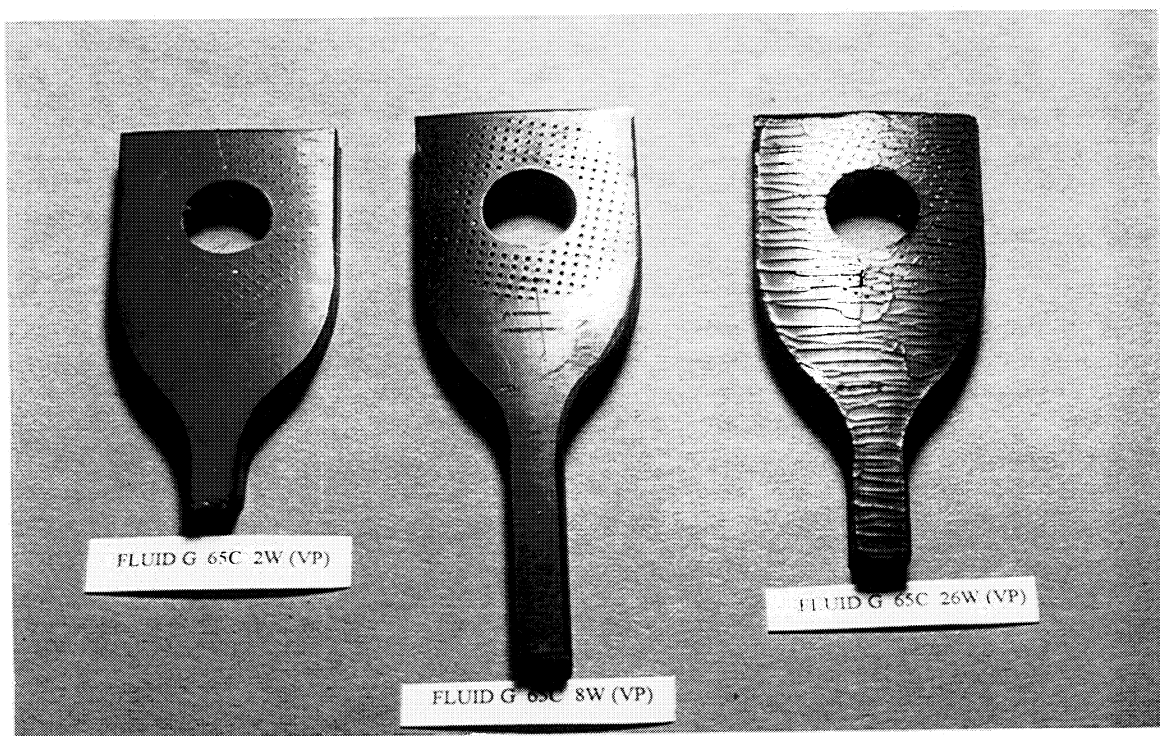
FIGURE 14 Effects of fluid G at 65C (reflux) on Coflon

The above data coupled with the stress-strain curves in Figures 10-13 clearly show the severe degradation, chemically-induced, caused by Fluid G. Modulus, break, strain and strength values all decrease with increased exposure time at all temperatures, although the lower two temperatures did indicate an initial rise in measured values prior to this decrease. Physical damage can also be seen from photographs in Figures 14-21, affecting surfaces and bulk regions also.

After the first exposure, for all temperatures, by cutting open some samples, they were found to be already black right through, with some surface cracking visible on certain of them. However, after testing, samples only displayed black colour on a thin 'casing' layer, see macrographs in Figures 15,17,19,21. The thickness of this black layer increased towards the centre as exposure times increased. It became apparent that the extent of black casing layer illustrated material which had suffered fast brittle fracture. The central remaining sample portions has failed in ductile mode, the ensuing "stress-whitening" largely masking the underlying black (so that colours were generally light brown).

Many longer exposures produced samples that were severely cracked prior to tensile testing, the longest-aged samples producing a fine powdered debris near the break region when disturbed. The presence of the cracks strictly diminished the original sample cross-sectional area, influencing modulus and strength values: however, any such effect has not been considered in calculating data for Table 3.

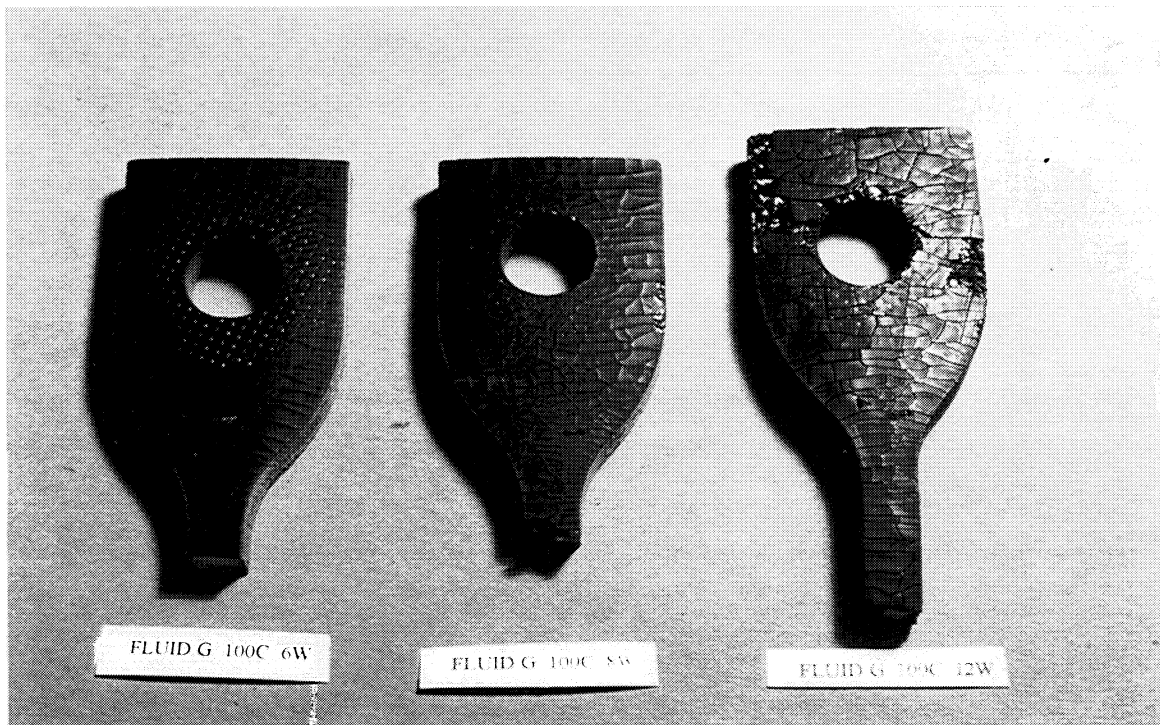
FIGURE 18 Effects of fluid G at 100C and 5kpsi on Coflon
